**GRETNA BLVD.  
500,000 GALLON ELEVATED WATER TANK REPAIRS**

BKI PROJECT NO: 9344-0100

ADDENDUM NO. 2  
DATE ISSUED: JANUARY 23, 2026

**Tank Inspection Report  
500,000 Gallon EST**

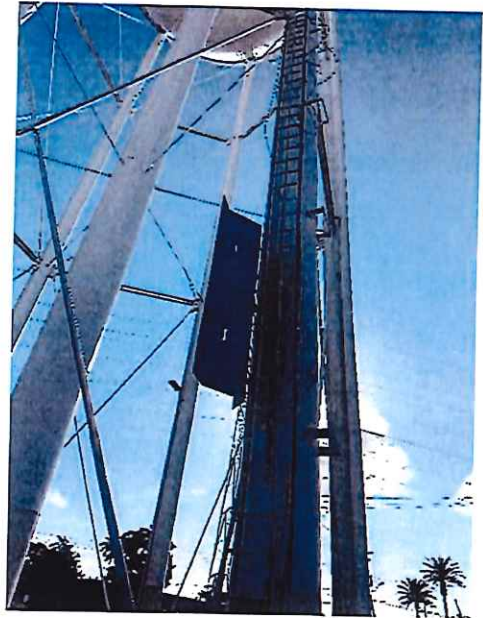
Exterior access ladder – good condition  
Ladder Gate/Vandal Guard – good condition

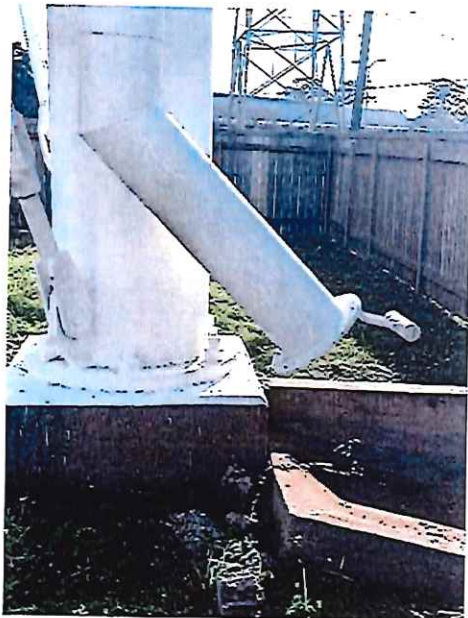
- **Ladder Gate Lock** – lock is present
- **Overflow Pipe** – The overflow pipe (12”) is in good condition. The coating exhibits mildew. There is surface rust on the bolts of the flap gate. Recommend installing stainless steel bolts.

Overflow Pipe – good condition  
Mildew

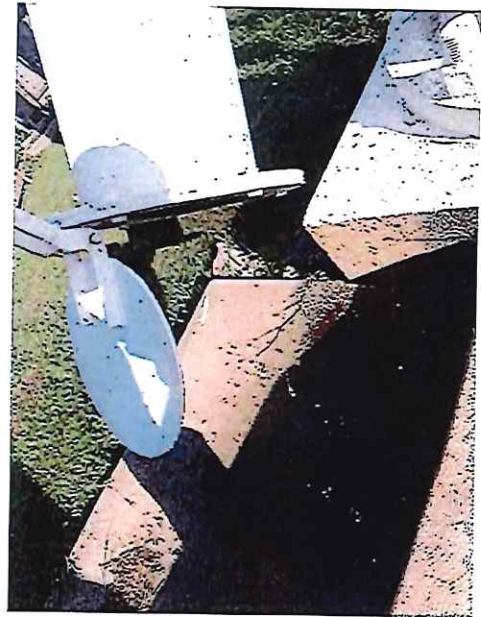
Flap Gate – install #24 non-corrodible stainless-steel screen

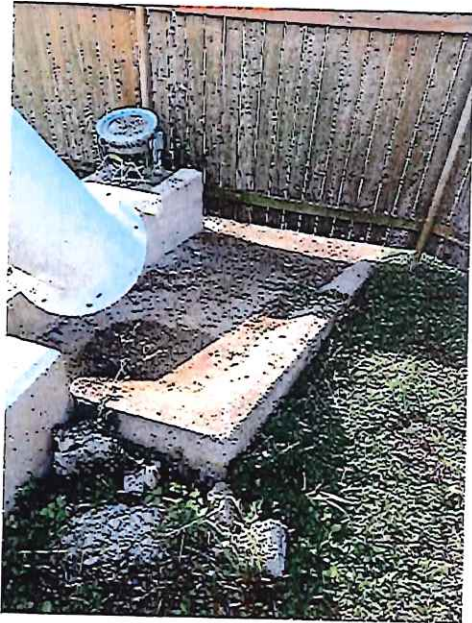
Splash Pad – good condition

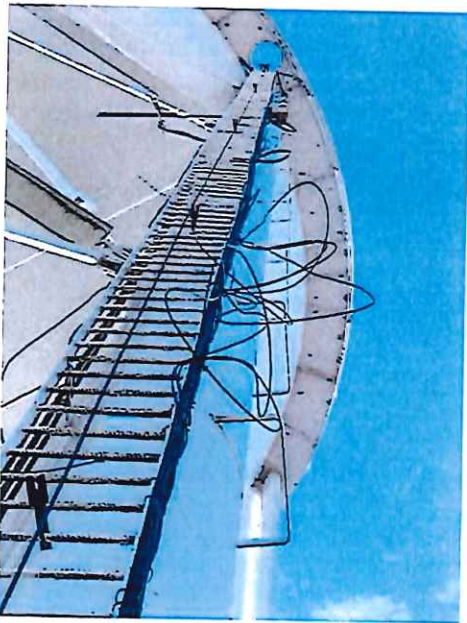
Hanging/tangled coax on the access ladder

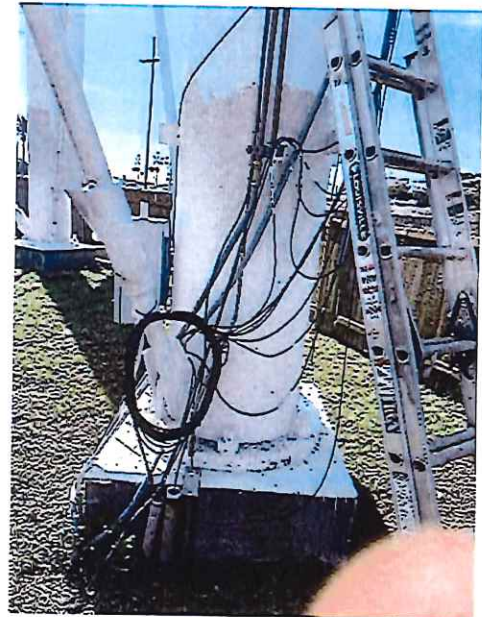
Excess coax to be removed and fastened to the ladder

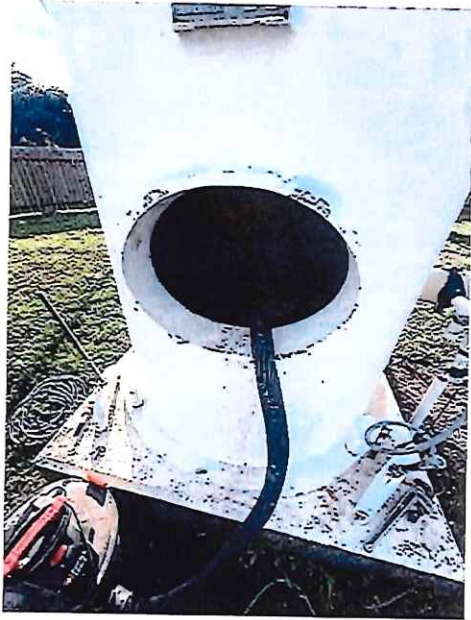
Riser manway – good condition  
Rusting around the opening

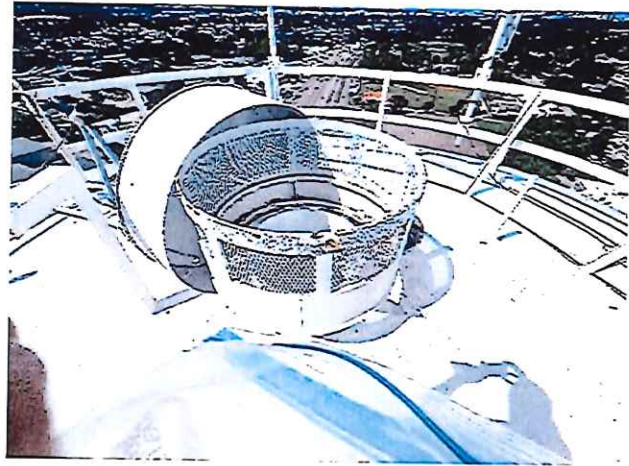
Roof Vent – severe rusting and deterioration

Recommend installing new clog resistant standard pressure vent

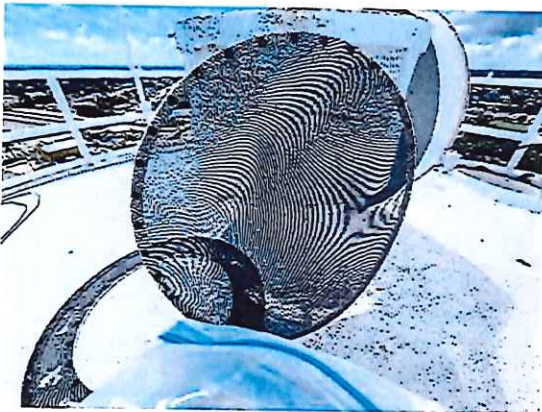
Vent screen installed 10/08/25 by  
Southern Coatings, LLC

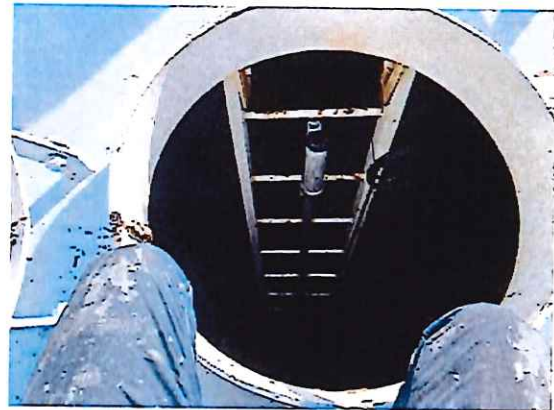
- **Access Ladder** – The interior access ladder exhibits severe rusting. The access ladder is equipped with a safety climb device, but it is deteriorated. Recommend installing LAD SAF safety climb device.
- **Riser Ladder** – The riser ladder exhibits severe rusting. The riser ladder is equipped with a safety climb device but it is deteriorating. Recommend installing LAD SAF safety climb device.
- **Cone Ladder** – The cone ladder exhibits rusting. The safety climb device is deteriorating. Recommend installing LAD SAF safety climb device.
- **Weir Box** – The weir box appears to be in good condition

Interior access ladder – severe rusting

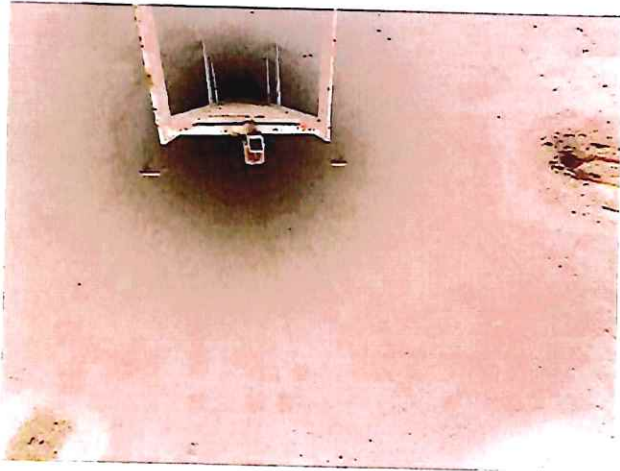
- **Riser** – The riser exhibits severe pitting, rusting, and paint failure. Recommend complete blasting and application of a 3-coat system. See Recommendations page for blasting and coating details.

Interior Riser – Severe rusting, pitting and paint failure.

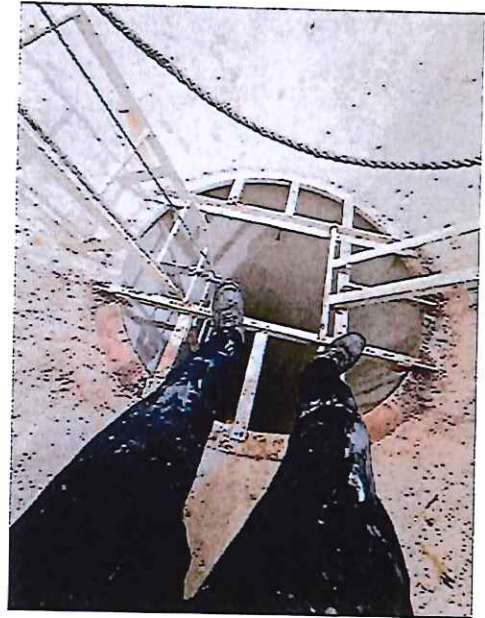
Riser Railing – good condition  
Rusting and paint failure

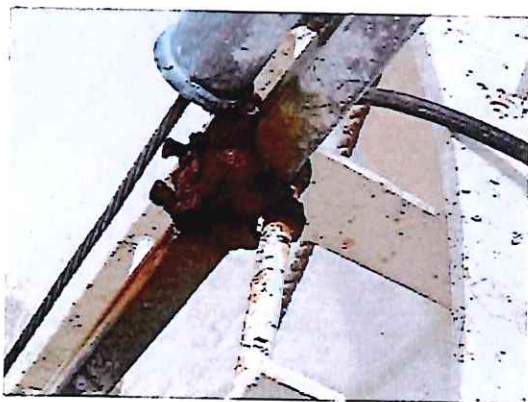
Cone access ladder – good condition  
Safety climb device to be replaced

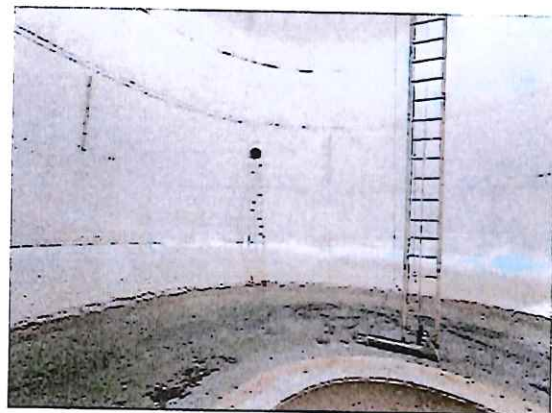
- **Walls** – The walls exhibit rusting from weld seams, pitting, and paint failure. Recommend complete blasting and application of a 3-coat system. See Recommendations page for blasting and coating details.

Interior Walls – rusting at seams

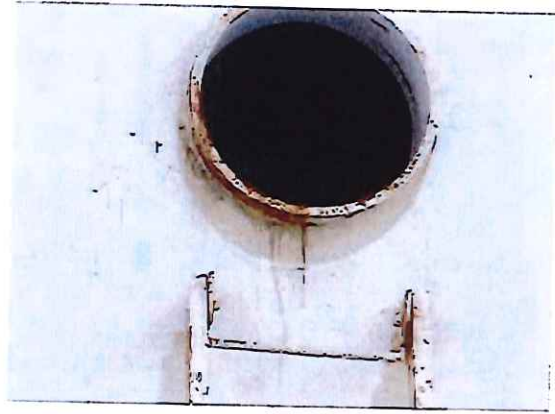
Balcony Manway – rusting around the opening

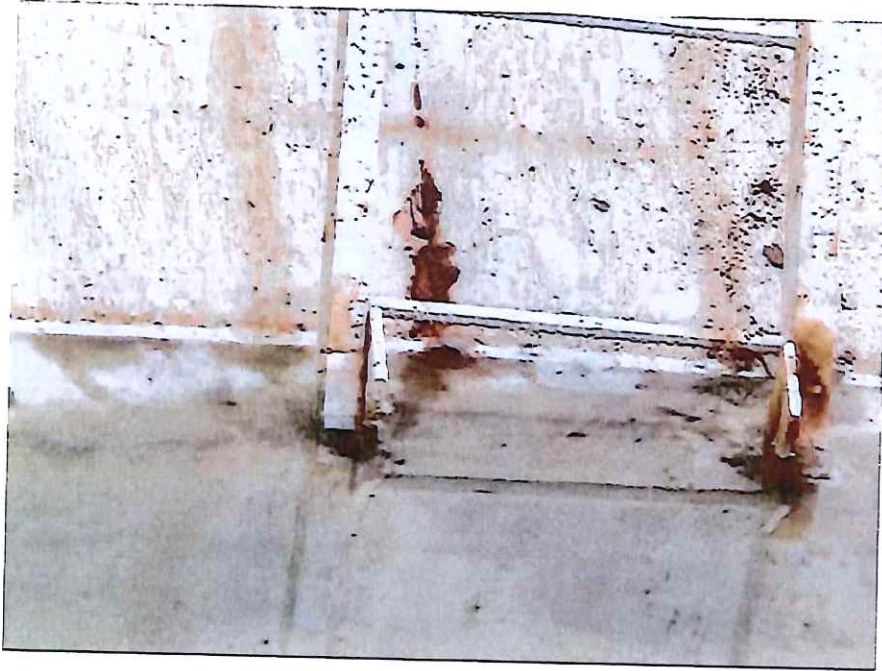
Interior walls – pitting, rusting, chalking, paint failure

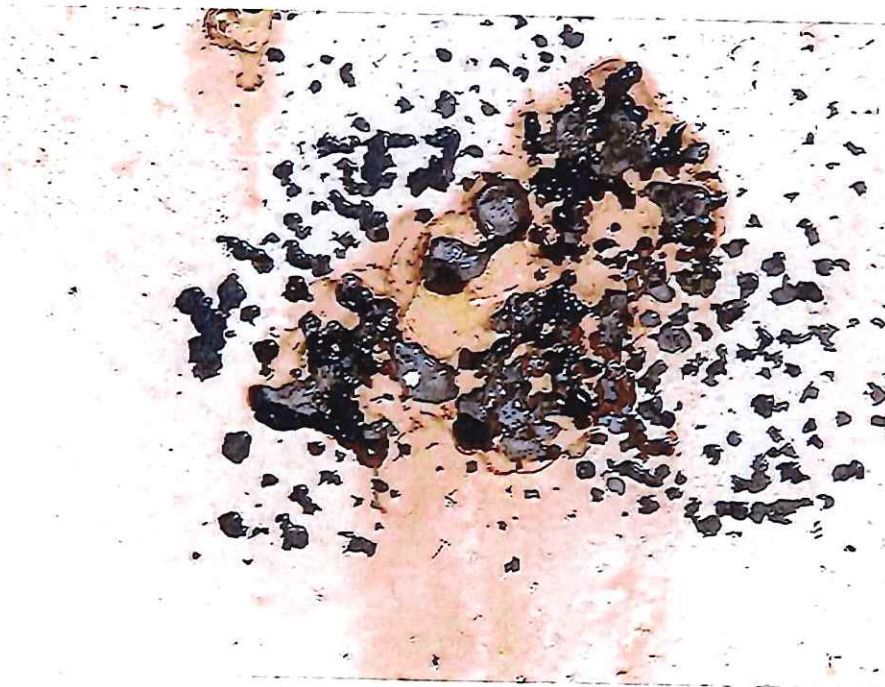
- **Floor** – The floor exhibits severe pitting, rusting, and paint failure. There are approximately 100 pits in the floor; 70% of those pits will require welding a metal patch to fill and 30% will require pit filler. Recommend complete blasting and application of a 3-coat system. See Recommendations page for blasting and coating details.

Interior Floor – Severe Pitting, paint failure and rusting

- The pitting in the floor that will require patching procedure follows:
  - Weld a 3”x 3” x ¼” metal patch to the floor of the tank.
  - SSPC – SP3 Power Tool clean all patches to a smooth surface and feathered edge for adequate adhesion of coating system.
    - First Coat – to be applied to all power tooled areas – Tnemec Series L-140 Pota – Pox Plus (2.0-10.0mL)
    - Second Coat – to be applied to all primed areas – Tnemec Series L-140 Pota – Pox Plus (2.0-10.0 mL)

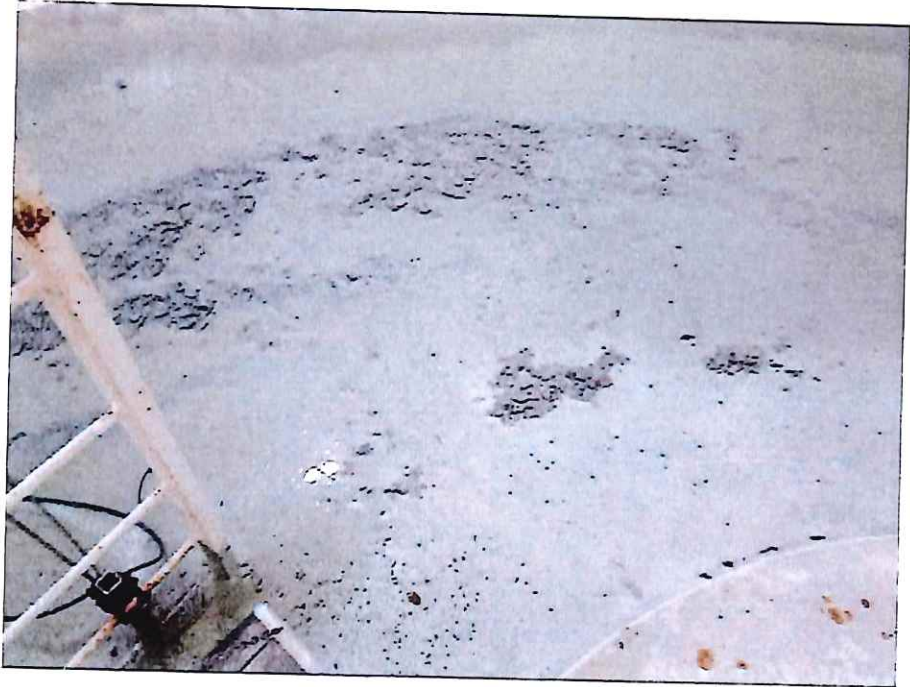
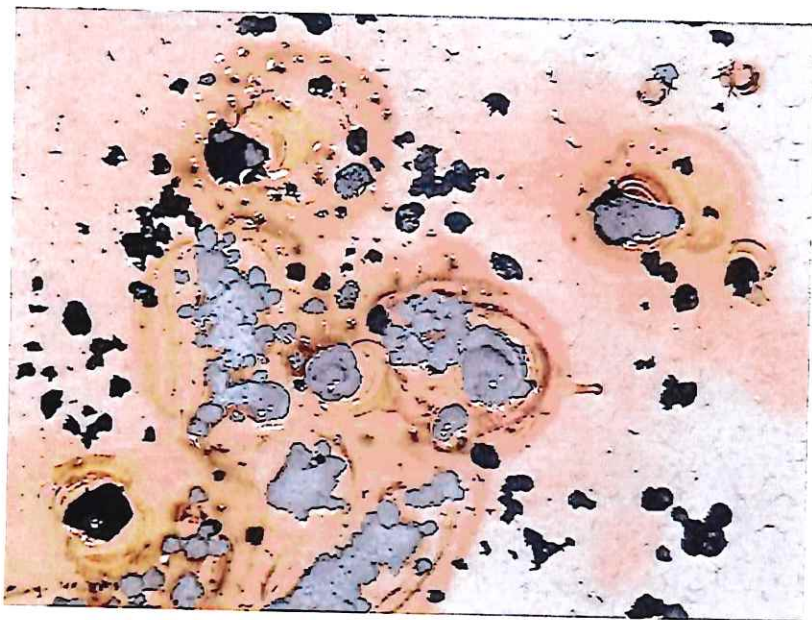
Interior Floor – Severe Pitting, paint failure and rusting

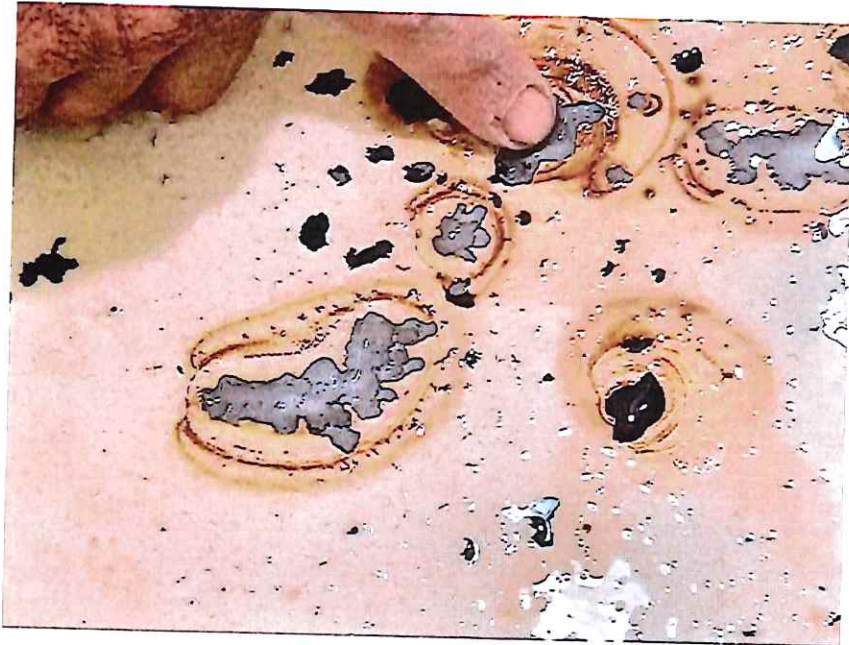
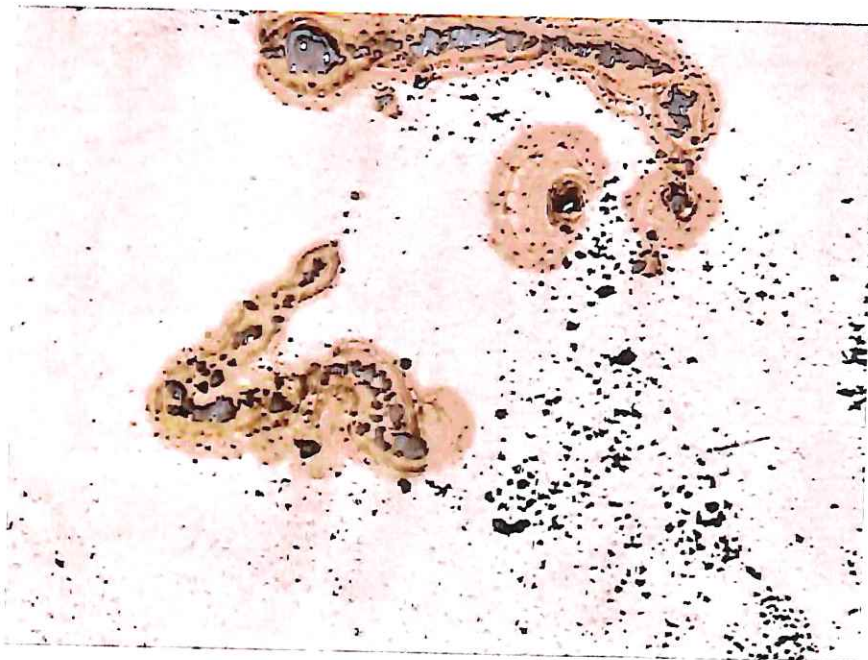
Interior Floor – Severe Pitting, paint failure and rusting
