# **GUIDELINES: REPAIR & RENOVATION**

The following guidelines are designed to assist owners, residents, and contractors interested in repairing or renovating a historic property within Gretna's two historic districts. The information and examples provided here can benefit both small- and largescale projects. The section begins with an introduction to various preservation approaches, from simple repairs to large-scale alterations. Major building components—foundations, porches, exterior woodwork, windows and doors, walls, and roofs—are then addressed in detail, with specific information about function, historic context, design, maintenance, repair, and replacement.

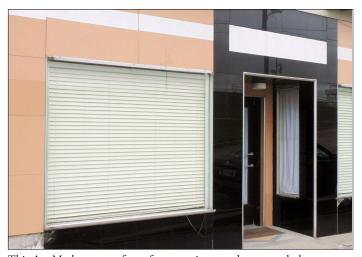
A variety of ornament adorns this masonry commercial building.

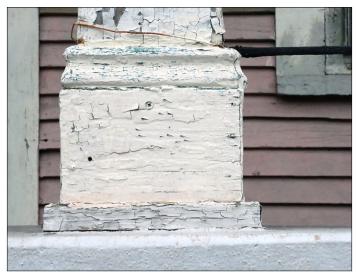
Example of maintenance: This porch column needs to be sanded, primed, and repainted.

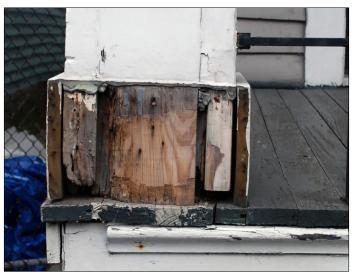
Example of repair: A piece of trim on this column base has fallen off and needs to be reattached.

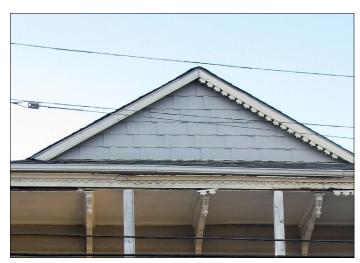
Example of replacement: The missing ornamental trim on the gable's left side should be replaced to match the trim on the right.

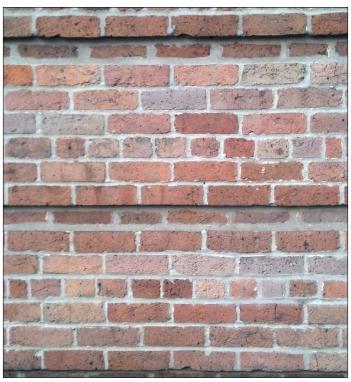
This masonry wall features decorative coursing.

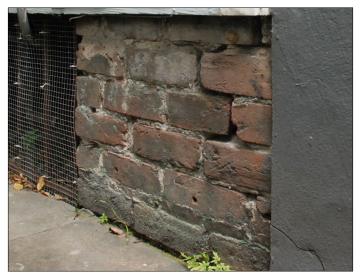
The mortar on this foundation wall is cracking and falling out in places. The brick is in need of repointing.

One issue that frequently arises involves the use of inappropriate mortar mixes during repointing. Repointing is the process of repairing mortar joints by carefully removing and replacing damaged or missing mortar. Historically, mortar was composed of sand, lime, water, and the occasional additive (such as animal hair.) Starting in the nineteenth century, small amounts of Portland cement were included to improve workability and setting time, with the proportion of Portland cement gradually increasing over the last century. Whereas older high-lime mortars were

In addition to selecting the right chemical composition of mortar, it is important to match the appearance, size, and profile of existing joints during any repointing job. The color and texture of the new mortar should match the unweathered interior portions of the historic mortar. Similarly, any new brick or stucco used to repair a masonry wall should match the physical characteristics of the existing material.

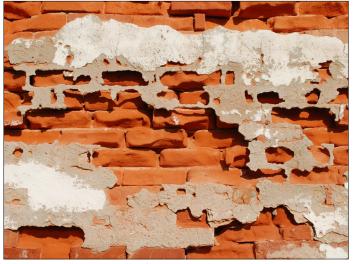
This is an extreme example of what happens when an inappropriately hard cement-based mortar is used on historic local soft brick. The brick wears away while the mortar, which should be "sacrificial" and fail first, remains intact.

soft, porous, pliable, and designed to work well with soft brick, the newer, harder mortars with a high Portland cement content were designed to be compatible with newer, harder brick. Problems arise when people inappropriately use hard, modern mortars on older, softer brick, which can cause substantial damage over time.

Mortar should be slightly softer and weaker than brick, so that over time it will fail first. In that sense it is considered "sacrificial," as it is far preferable to repoint a brick wall or pier than to replace it entirely.

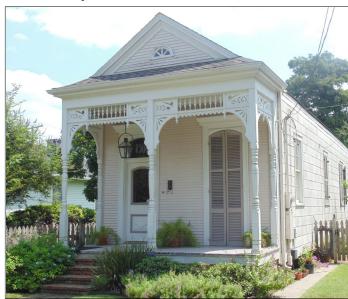
This Eastlake porch retains many of its original features, including brick steps, tongue-and-groove porch floor, turned posts, and decorative spindle frieze.

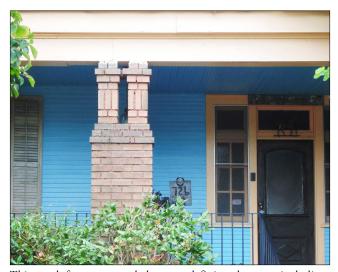
This porch features several character-defining elements, including paired brick columns, weatherboards, louvered shutters, and door/ transom assembly.

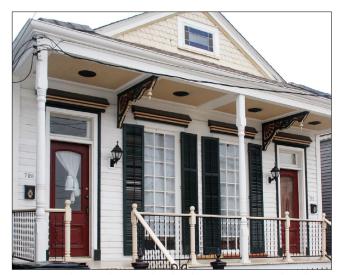
Do not combine architectural styles that are not original to the building. This shotgun has been modified to have both Italiantate brackets and Eastlake columns.
